VicUrban

Preliminary Site Contamination Assessment Corner McCubbin Drive and Robertsons Road Taylors Lakes Victoria

10 June 2010
REF: 1042RPT01-F

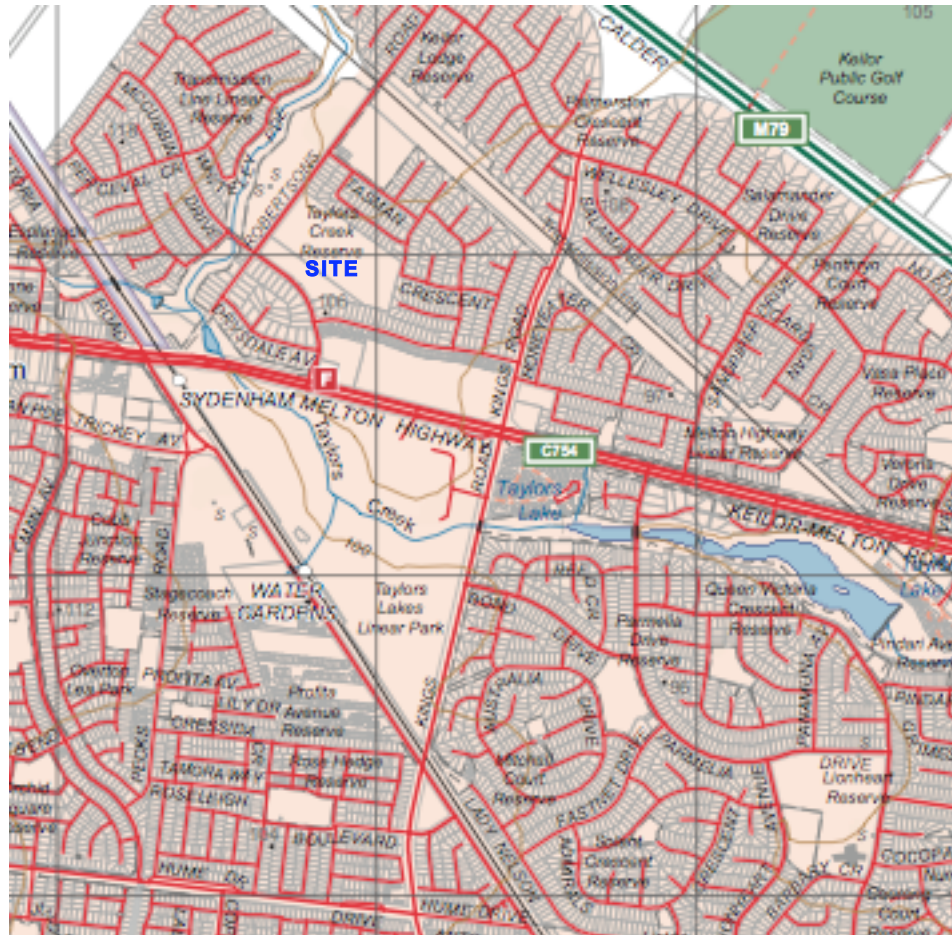
Map No. T7822-1-3-3

The site is relatively flat with a ground elevation of approximately 106 m AHD. The local topography shows a slight slope down towards Taylors Creek to the south west of the site (refer to topographic map below).

VicMap Topographic Map 1:30,000

(Note, all elevations are provided in m AHD)

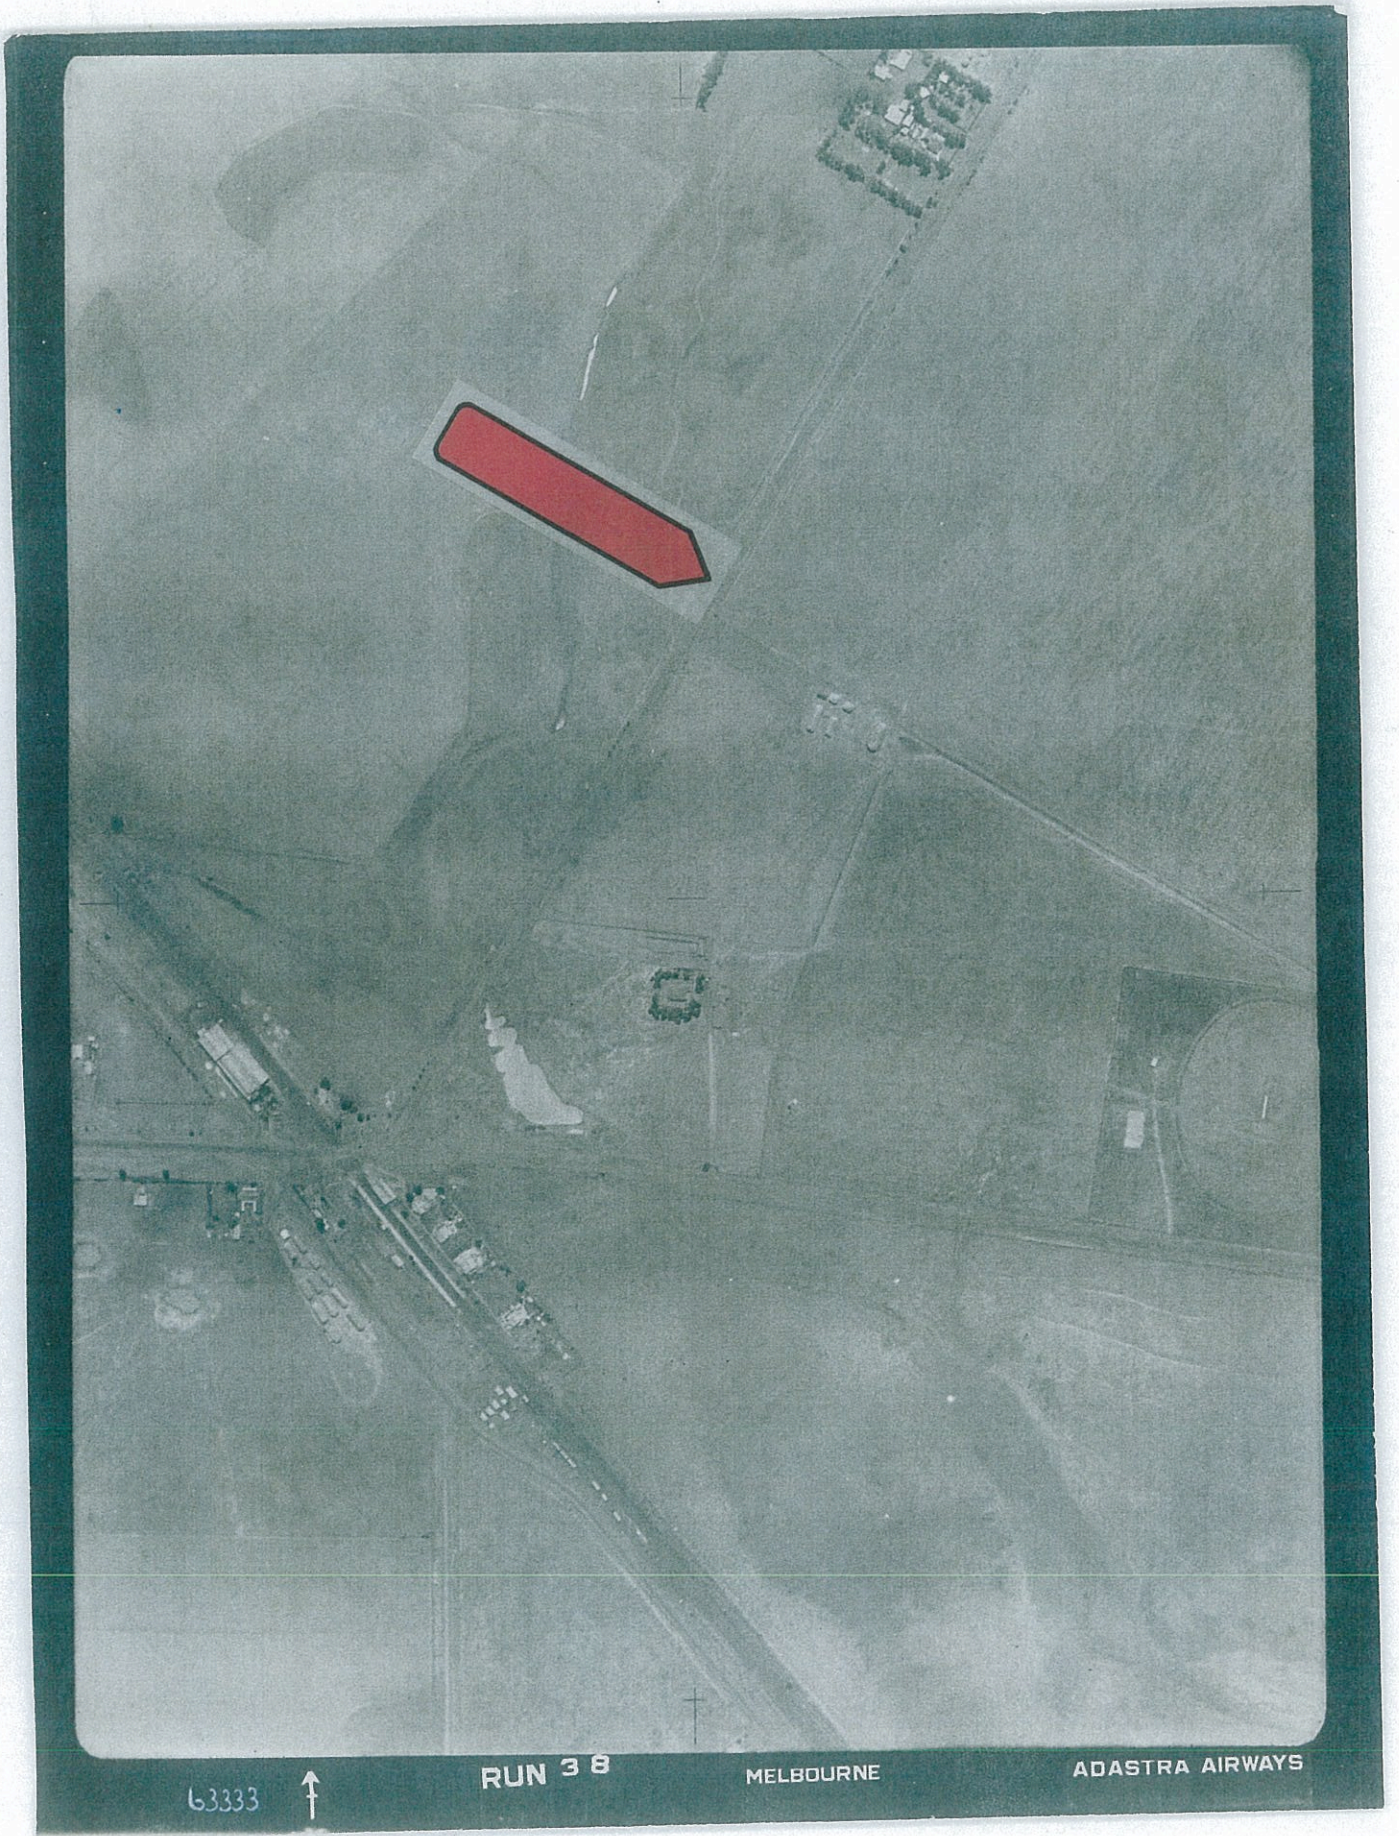
Aerial Photograph: December 1945

Photograph	Observations
12/1945 Run: 38 Film: 229 Photo: 63333 Scale: 1:6000	<p>Site: The site appears to be grazing / farmland. Three small square structures and three larger rectangular structures are visible in the central west. These structures appear to align along the current boundary between the two land parcels. A road extends along the (current) boundary line (east / southeast to west / northwest) and curves perpendicularly toward the southwest at the point of intersection with the location of the buildings.</p> <p>Surrounding area: The surrounding area appears to be grazing or farmland. No structures are visible in the immediate vicinity of the site. A rural property with buildings is visible to the north (west of Robertsons Road).</p> <p>A second property with a large water body is present in the south. This water body appears to be fed by Taylors creek, which runs north to south (west of Robertsons Road) and curves toward the east, crossing through the property.</p> <p>A cricket ground is visible to the east / southeast. The Sydenham railway line extends northwest to south east adjacent to Sydenham Road. Associated buildings and rail carriages are visible.</p>

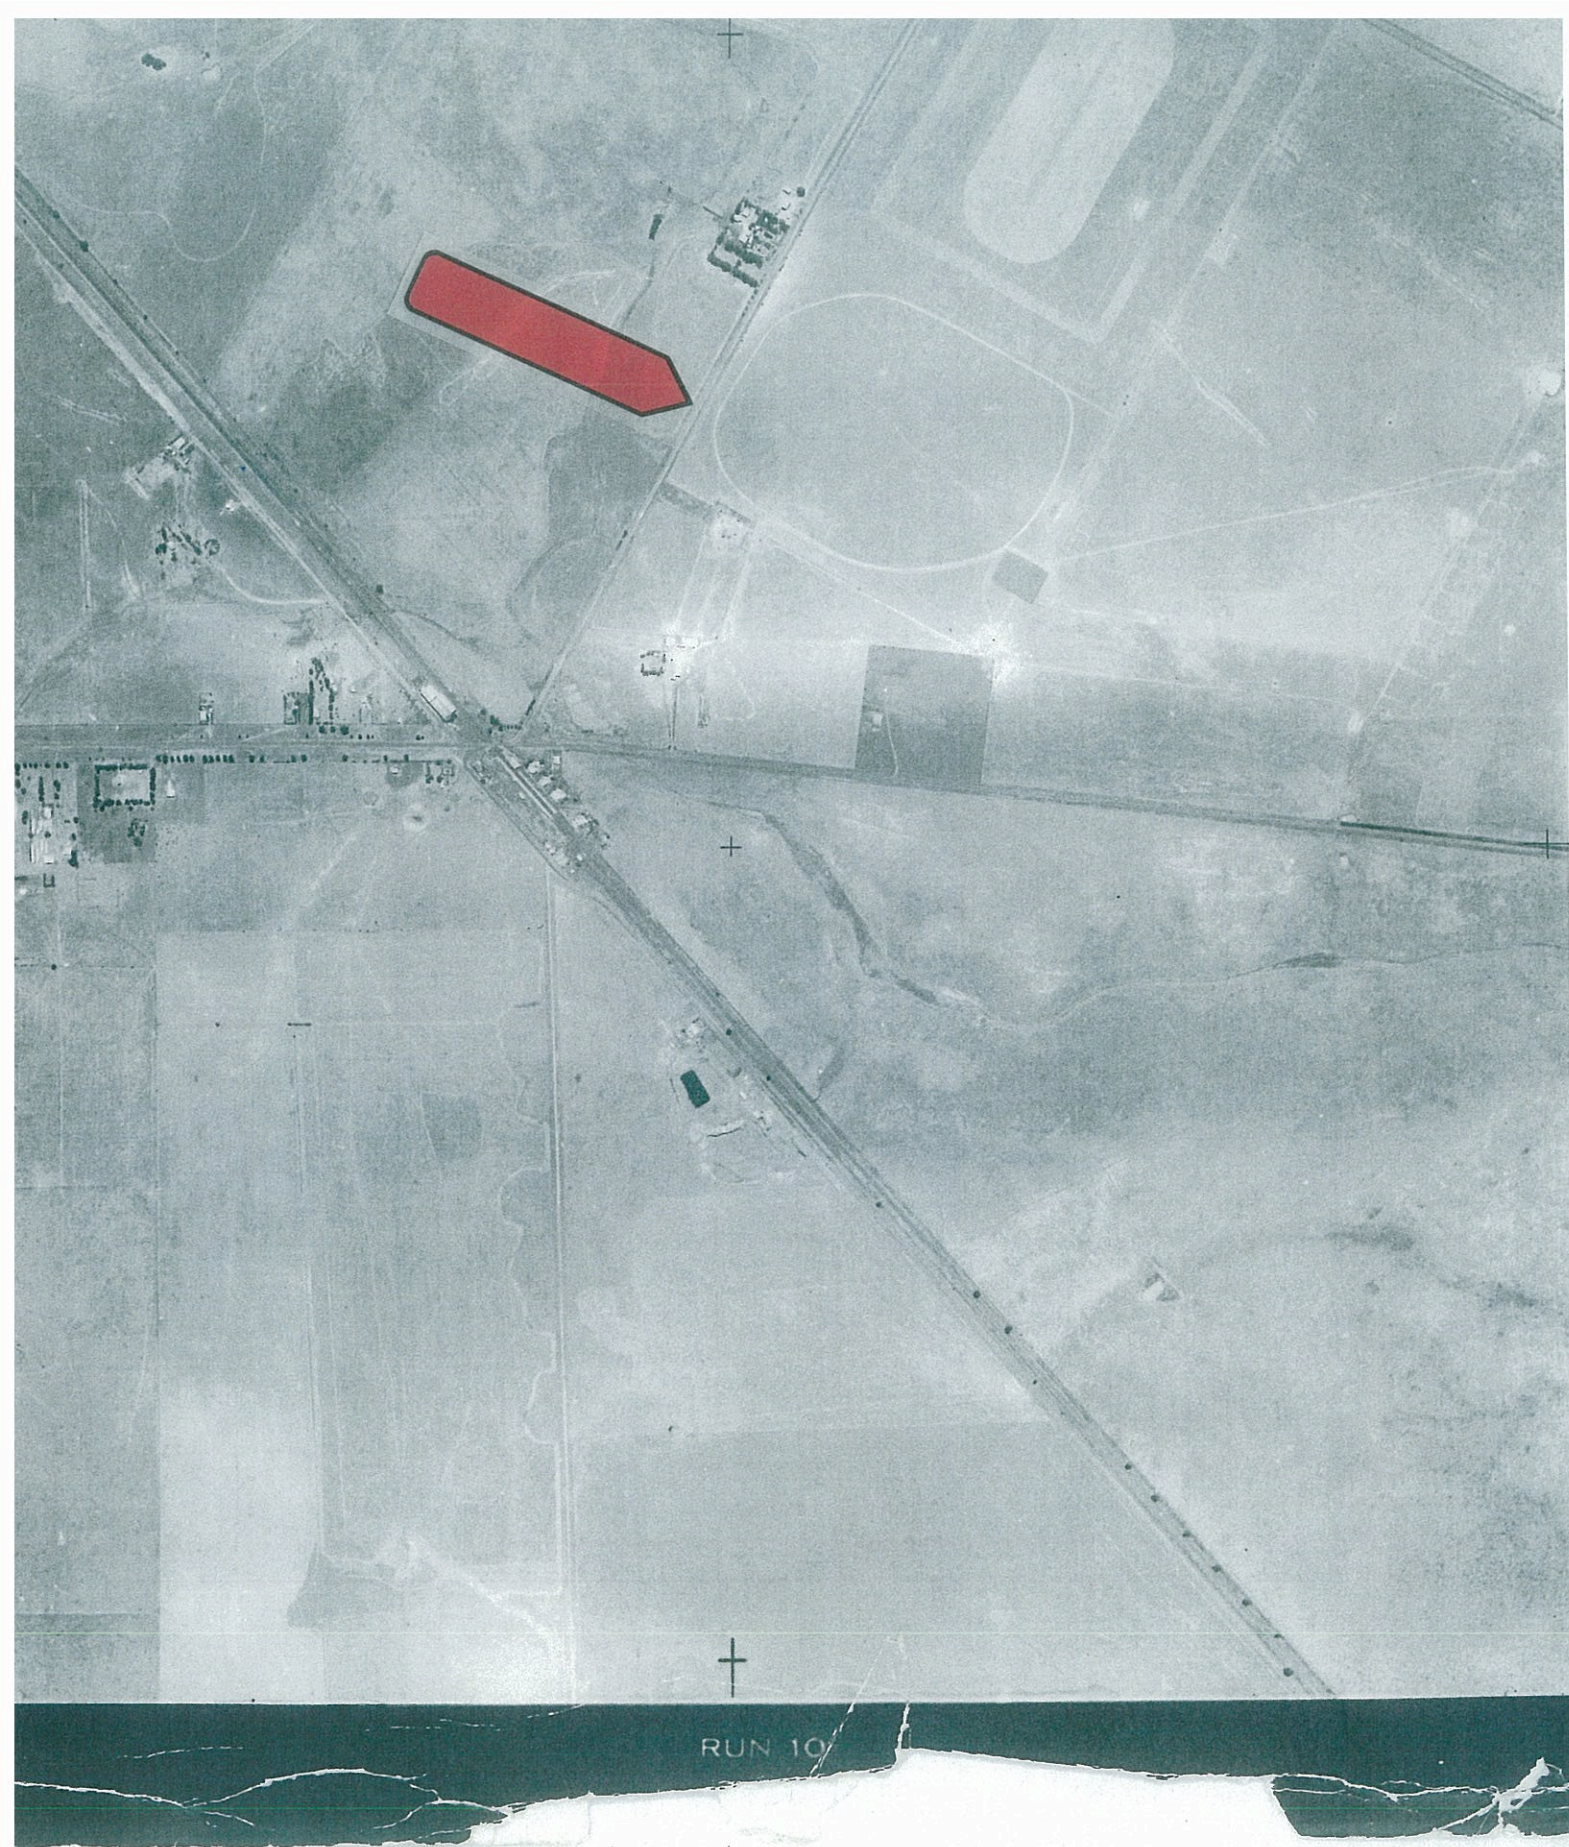
Aerial Photograph: January 1951

01/1951 Run: 10 Film: 1423 Photo: 2 Scale: 1:12000	<p>Site: Some disturbance to the structures in the central west is evident, with dirt roads or tracks extending behind the buildings; leading south. A small line of trees has been planted in front of the buildings. A large elliptical track is visible on the site and extends across the land immediately north.</p> <p>Surrounding area: No significant change appears to have occurred. Some disturbance is visible on the property to the south of the site. A large area to the north appears to have been cropped or graded, with an ovoid appearance.</p>
02/1960	<p>Site: Three of the previous structures are visible in the central west behind the tree line. An</p>

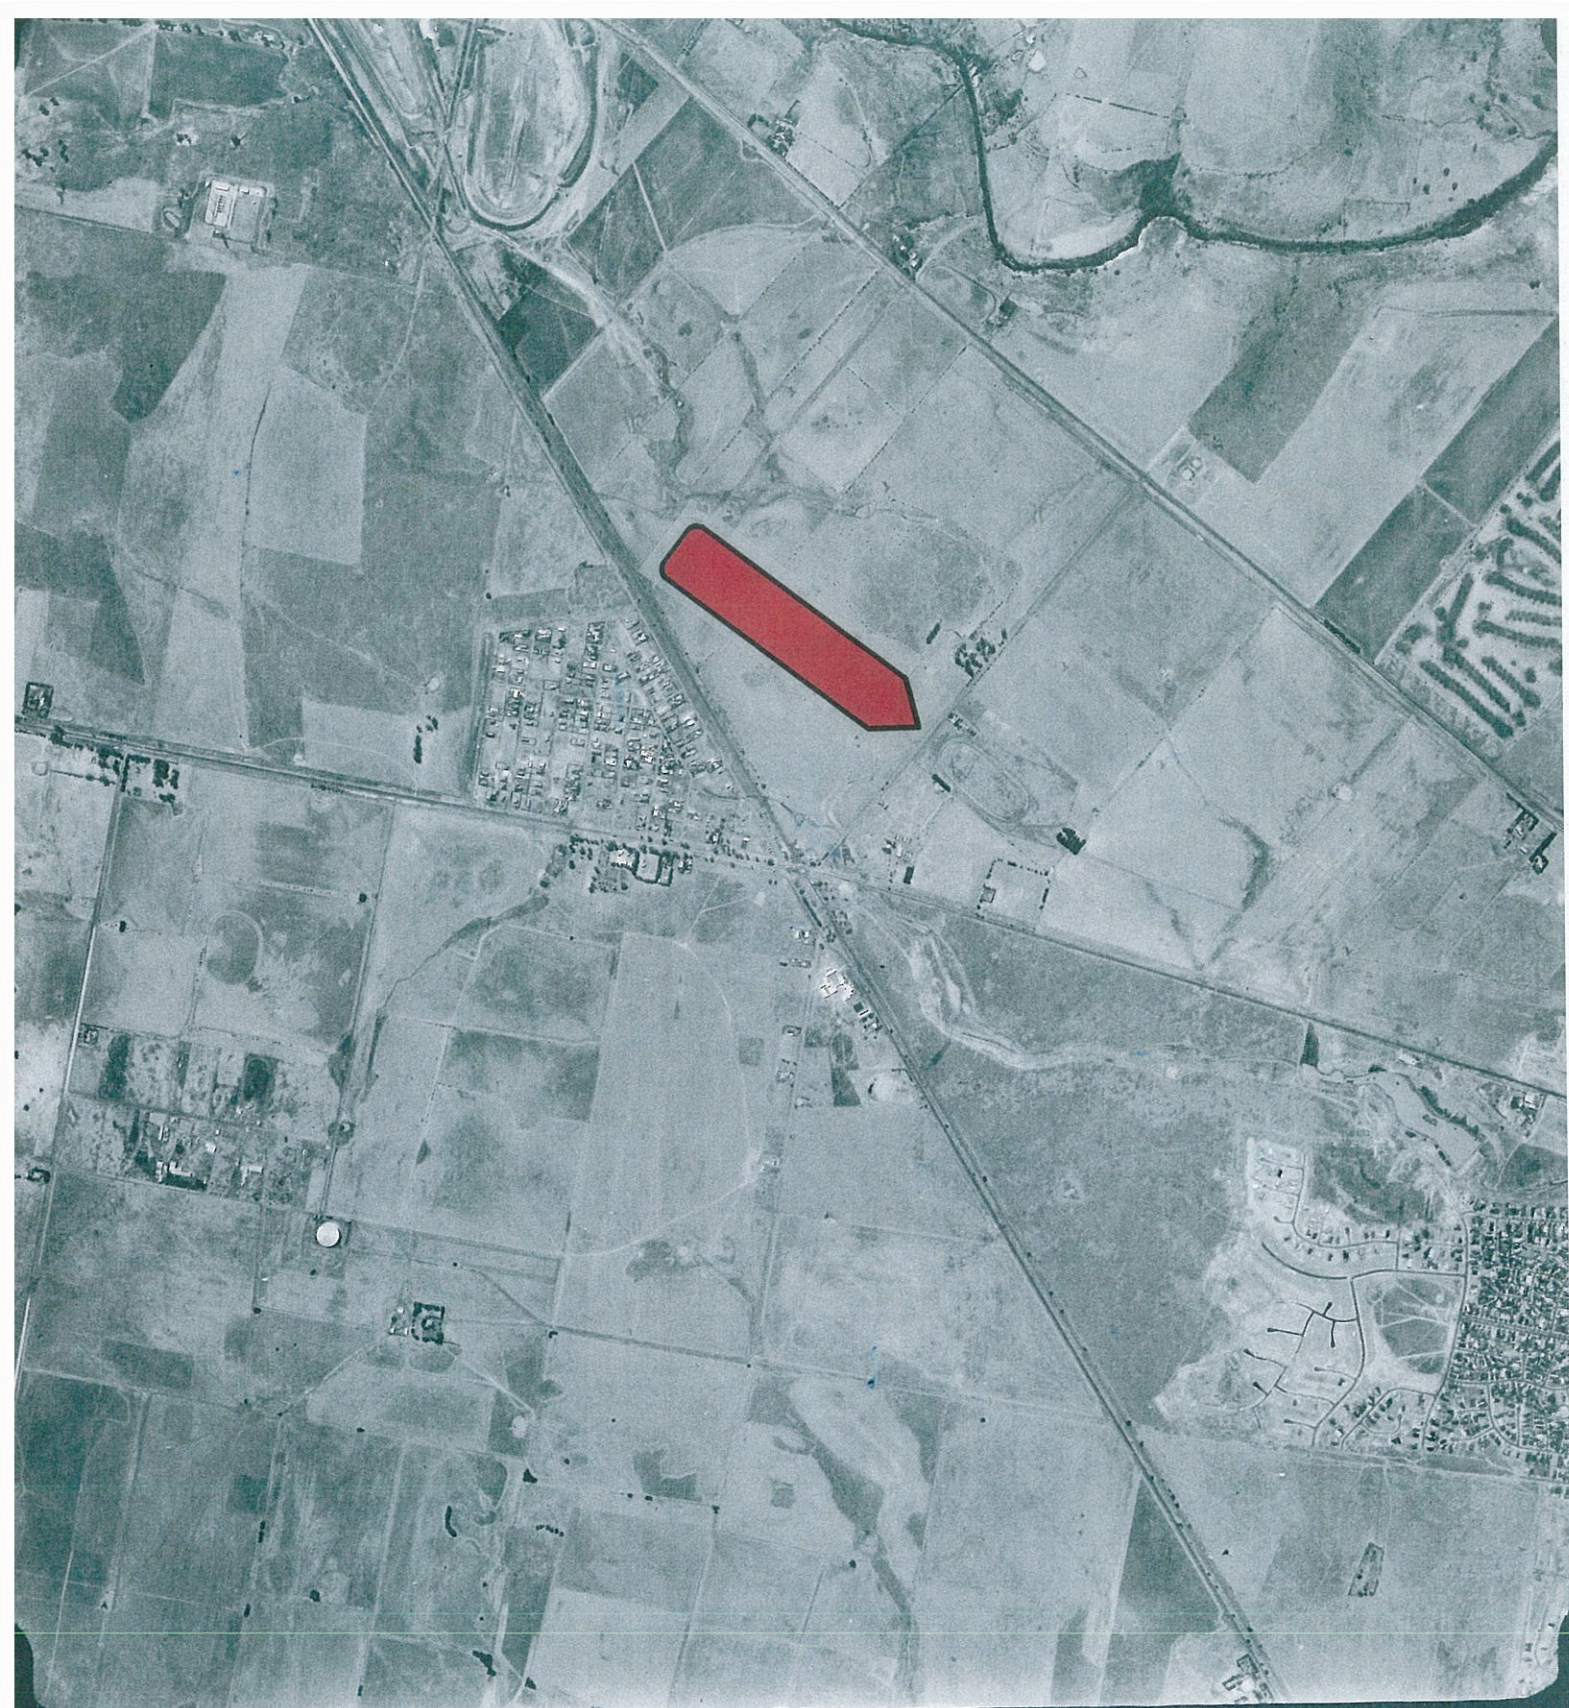
Aerial Photograph: March 1975

03/1975 Run: 29 Film: 2937 Photo: 60 Scale: 1:10000	Site: Two buildings are visible behind the tree line in the central west. Surrounding area: A residential structure with a semi-circular driveway is visible to the northwest of the trotting track, facing Robertsons Road. Three rectangular buildings are visible behind this residence. Residential development has commenced between Sydenham Road and Keilor – Melton Roads (to the west). Occasional properties are visible along Pecks Road (south). No other significant changes are visible.
03/1986 Run: 6 Film: 4019 Photo: 167 Scale: 1:25000	Site: No significant changes are visible. Surrounding area: Residential development has increased between Sydenham Road and Keilor – Melton Roads, (and in the greater area to the south east) with residential road layouts now visible. No other significant changes are visible.
10/1990 Run: 1 Film: 4347 Photo: 22 Scale: 1:10000	Site: An outer sand track is clearly visible surrounding the surfaced track. Some disturbance on the inner boundary of the track is present. The buildings in the central west are no longer present. Surrounding area: Four small square buildings are present behind the residence northwest of the trotting track (replacing one of the rectangular buildings). Residential development has continued between Sydenham Road and Keilor – Melton Roads, with residential roads now surfaced. Further development has occurred along Sydenham Road to the south. Roads have been laid and surfaced in the east. No other significant changes are visible.
