Places Victoria
Taylors Lakes Development
Geotechnical Investigation Report

April 2016

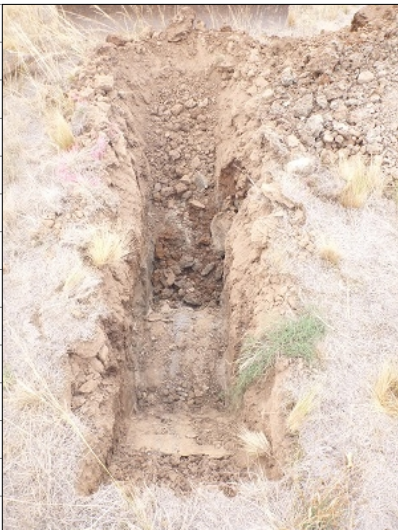
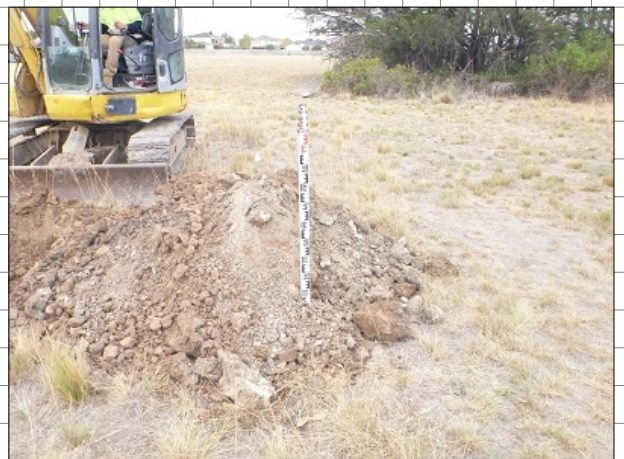
| EXCAVATION | | | MATERIAL | | | | | Comments Observations | |
|---|---|---|---|---|---|--|--|---|--|
| | | | 0.90 | | | boulders density increasing | | | |
| | | | | | | Testpit terminated at 0.9m upon refusal on boulders Testpit backfilled with spoil upon completion | | | |

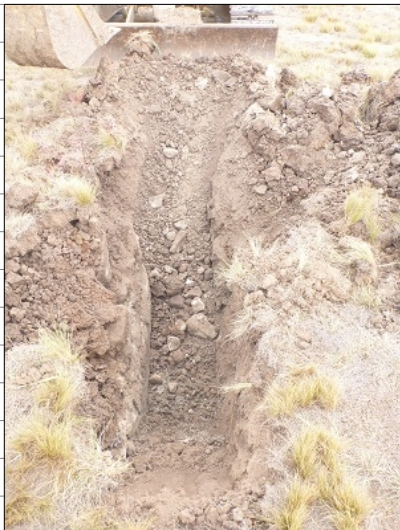
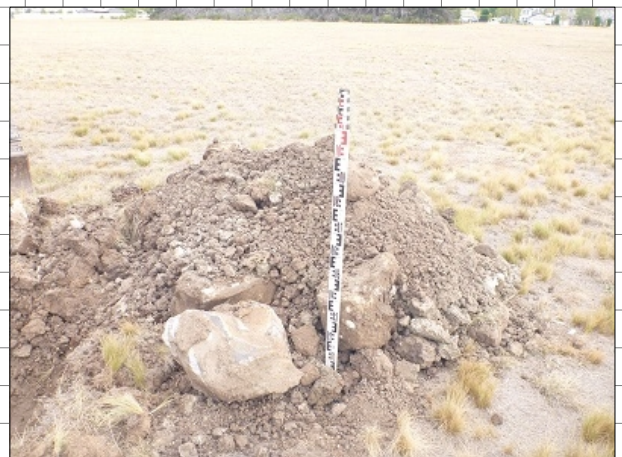
| EXCAVATION | | | MATERIAL | | | | | Comments Observations |
|---|---|---|---|---|---|--|---|---|
| | | | | | Cl-CH | CLAY with Cobbles, grey and brown, closely spaced fissure clay, trace tree roots up to 100mm in size, angular basalt cobble up to 110mm in size | | |
| | | | 0.70 | | CH | CLAY with sand, brown and pale grey, fine grained sand, pockets of calcium carbonate nodule up to 50mm in size, boulders density increasing, boulder up to 0.8m in size inclusions | | |
| 2 | | | 1.50 | | | Testpit terminated at 1.5m upon refusal on dense boulders Testpit backfilled with spoil upon completion | | |

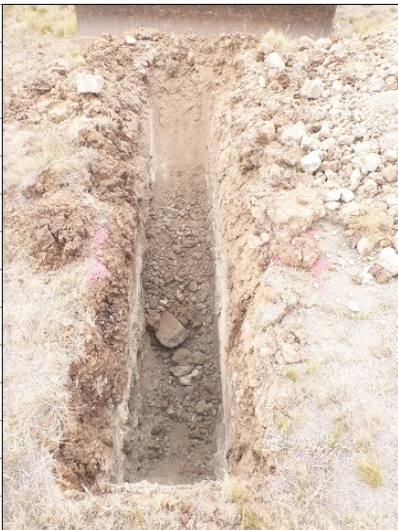
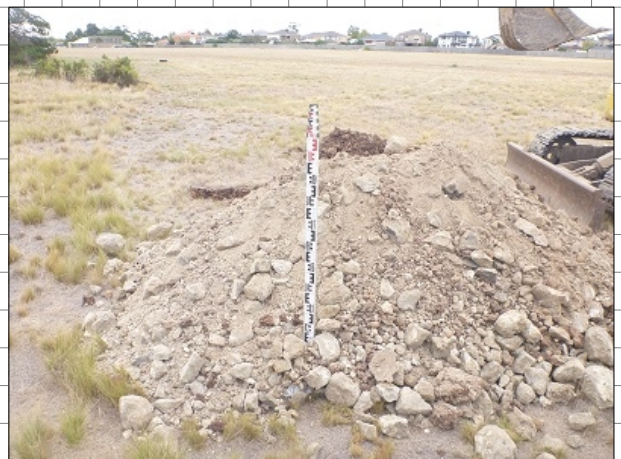
| EXCAVATION | | | MATERIAL | | | | | Comments Observations |
|---|---|---|---|---|---|--|---|---|
| | | | 0.50 | | CI | CLAY, pale yellow brown to yellow brown, closely spaced fissure clay, trace fine tree roots up to 300mm in size | | |
| 1.00 | | | GP | Cobble with clay, pale yellow grey, sub rounded to angular basalt cobbles up to 180-190mm in size | | | | |
| 2 | | | 1.90 | | | Testpit terminated at 1.9m upon refusal on dense cobbles Testpit backfilled with spoil upon completion | | 2 |

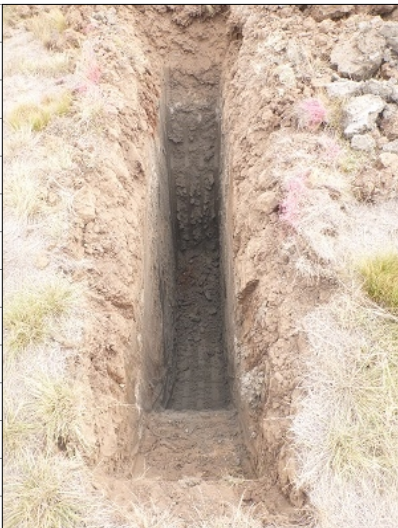
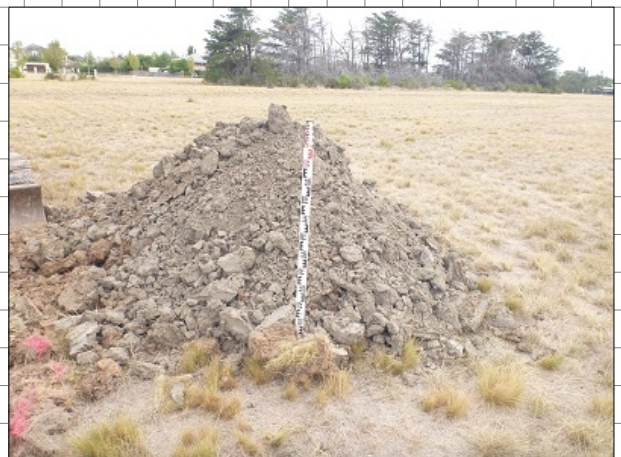
| EXCAVATION | | | MATERIAL | | | | | Comments Observations |
|---|---|---|---|---|---|--|---|---|
| | | | 0.30 | | Cl-CL | CLAY, yellow brown to dark yellow brown, trace fine tree roots, closely spaced fissure clay significant sandy lens up to 70mm in size | D-M M | |
| | | | 1.40 | | | occasional/trace cobble up to 300 mm in size | | |
| 3.00 | | | | | Testpit terminated at 3.0m Testpit backfilled with spoil upon completion | | | |

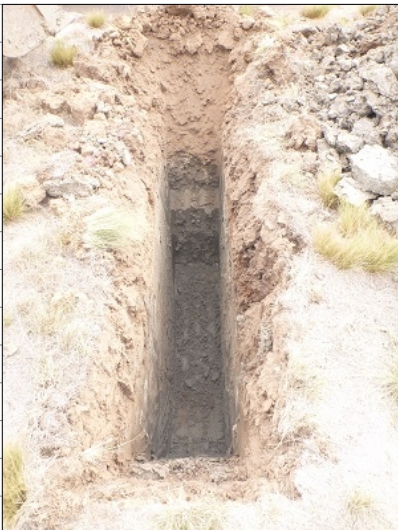
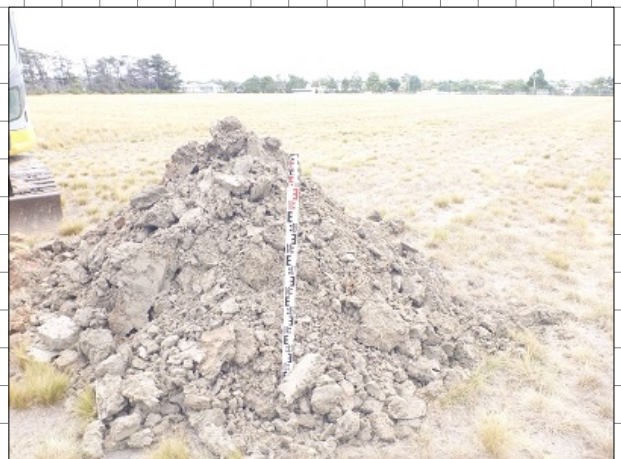
| EXCAVATION | | | MATERIAL | | | | | Comments Observations | |
|---|---|--|---|---|---|--|--|---|---|
| | | | | | CI | CLAY, pale yellow brown to yellow brown, closely spaced fissure clay, trace tree roots up to 80mm in size | D-M | | |
| | | | 0.50 | | CH | fissure content decreasing, becoming highly plastic | M | | |
| 1.10 | | | becoming grey | | | | | | |
| 3 | | | 3.00 | | | Testpit terminated at 3.0m Testpit backfilled with spoil upon completion | | 3 | |

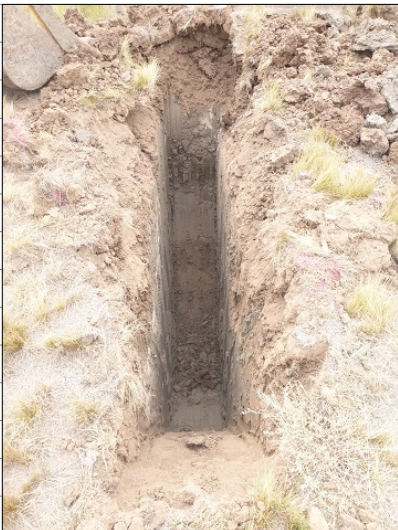
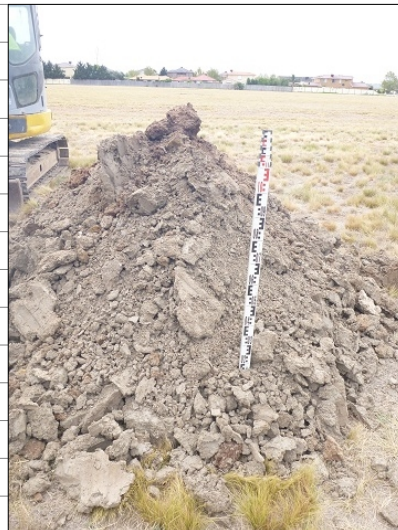
| EXCAVATION | | | MATERIAL | | | | | Comments Observations |
|---|---|---|---|---|--|--|--|---|
| | | | | | Cl-CH | CLAY, pale yellow brown to yellow brown, trace tree roots up to 70mm in size, closely spaced fissure | D-M | Residual soil |
| | | 0.90 | | CH | trace calcium carbonate nodule up to 20mm in size, fissure content decreased becoming highly plastic clay | M F-St | 1 | |
| 2 | GNE | D(1.5m) | 2.50 | | | trace angular basalt cobbles up to 120mm in size | | 2 |
| | | | 3.00 | | | Testpit terminated at 3.0m Testpit backfilled with spoil upon completion | | 3 |

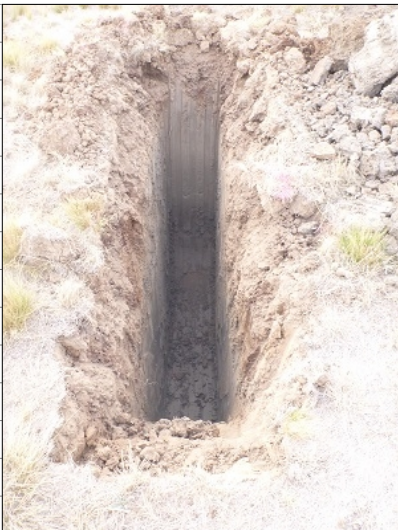
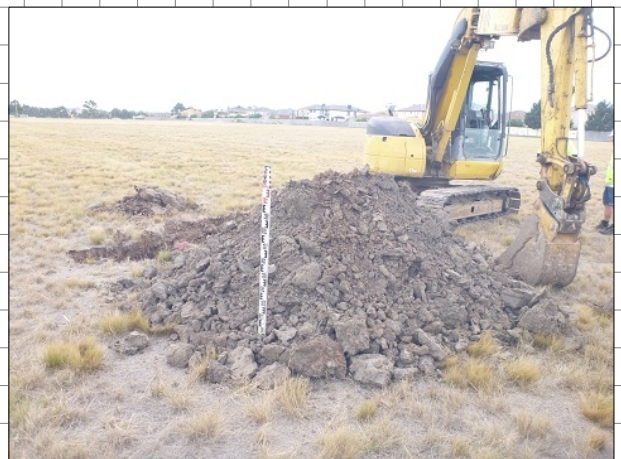
| EXCAVATION | | | MATERIAL | | | | | Comments Observations |
|---|---|---|---|---|---|--|---|---|
| | | | | | CI | CLAY, pale yellow brown to yellow brown, trace fine tree roots up to 100mm in size, closely spaced fissure clay | D-M St | Residual soil |
| | | | 0.45 | | | becoming yellow brown to brown, fissure content decreased | | |
| | | | 0.80 | | CH | becoming highly plasticity clay becoming grey brown | | |
| 3 | | | 3.00 | | | | Testpit terminated at 3.0m Testpit backfilled with spoil upon completion | |

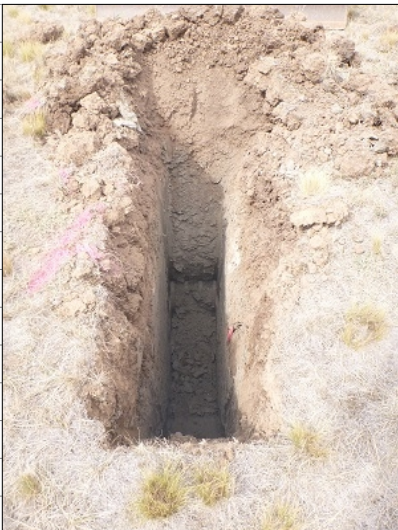
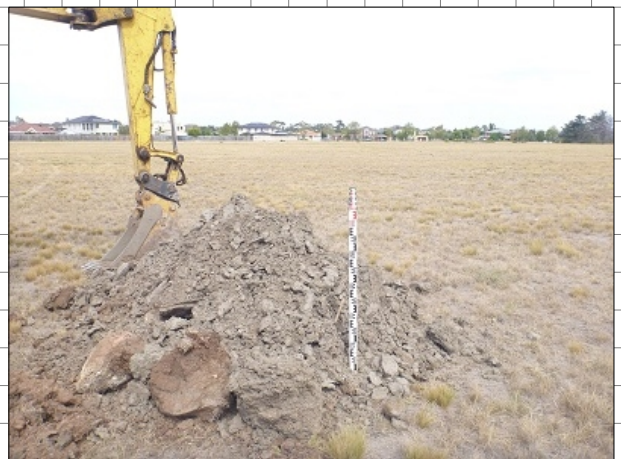
| EXCAVATION | | | MATERIAL | | | | Moisture Condition / Consistency / Relative Density | Comments Observations |
|---|---|---|---|---|---|--|---|---|
| | | | | | Cl-CH | CLAY, yellow brown, trace tree roots up to 80mm in size, closely spaced fissure clay | D-M | |
| | | | 0.50 0.60 | | CH | trace/occasional angular basalt, highly vesicular cobble up to 350mm in size becoming highly plastic clay, grey brown, trace calcium carbonate nodule up to 50mm in size | | Residual soil |
| 3 | | | 3.00 | | | | | Testpit terminated at 3.0m Testpit backfilled with spoil upon completion |

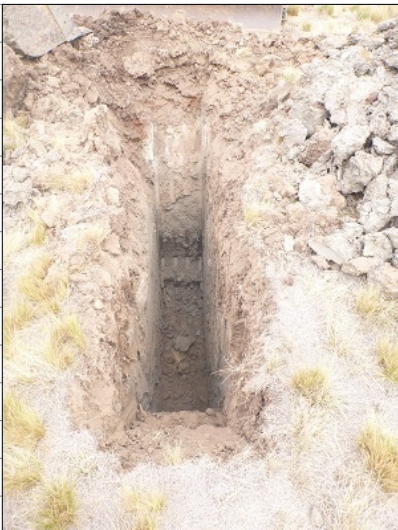
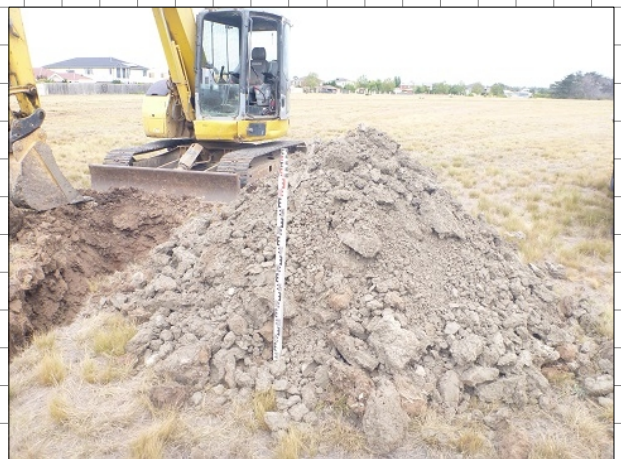
| EXCAVATION | | | MATERIAL | | | | | Comments Observations |
|---|---|---|---|---|---|--|---|---|
| | | | | | CH | CLAY, pale yellow brown to yellow brown, closely spaced fissure clay, trace tree roots up to 80mm in size | D-M | Residual soil |
| | | | 0.50 | | | occasional/ trace slightly vesicular angular basalt boulder up to 0.45m in size, fissured content decreased, trace nodule of calcium carbonate up to 20mm in size becoming pale grey brown | | |
| 3 | | | 3.00 | | | Testpit terminated at 3.0m Testpit backfilled with spoil upon completion | | |

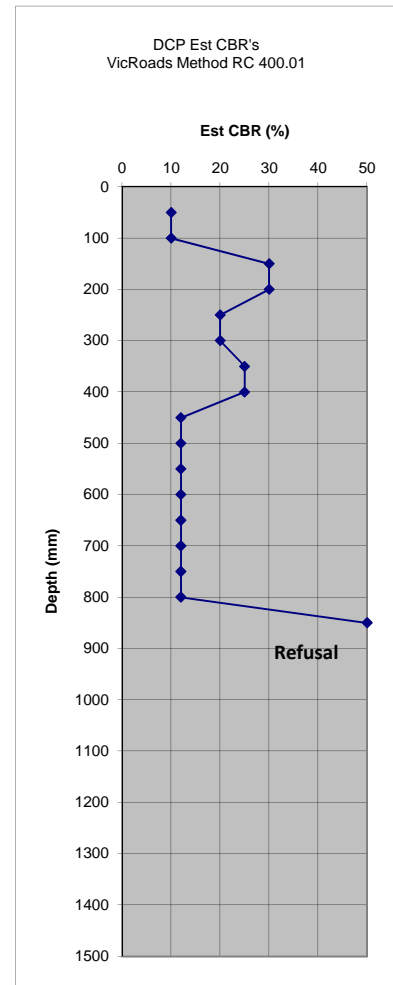
This method covers the calculation of the estimated California Bearing Ratio (CBR) of cohesive soils from the penetration results obtained using the dynamic cone penetrometer described in AS 1289.6.3.2

Caution: The CBR data derived using this method should be used with care and due consideration should be made of soil moisture condition at the time of the test in relation to that expected during service life of the pavement.

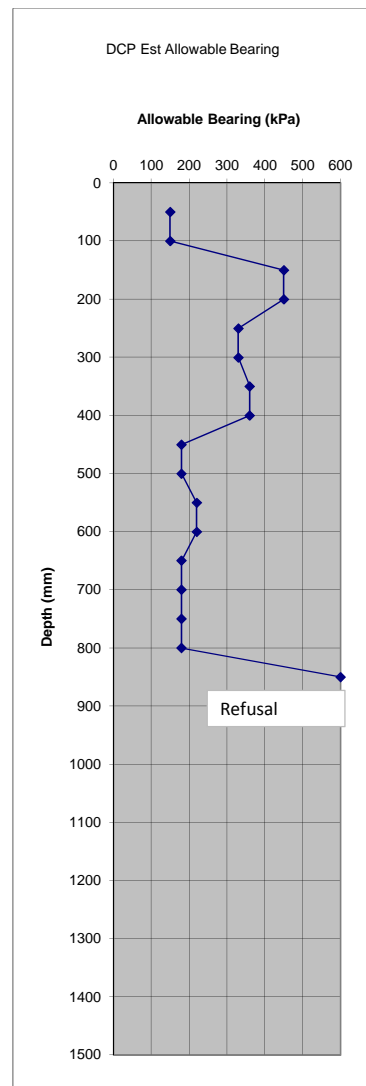
Approximate $C_u = 0.8 \times$ allowable bearing capacity.

Caution: The Allowable Bearing derived using this method should be used with care and consideration should be made of soil moisture condition at the time of the test in relation to that expected during service life of the foundation.

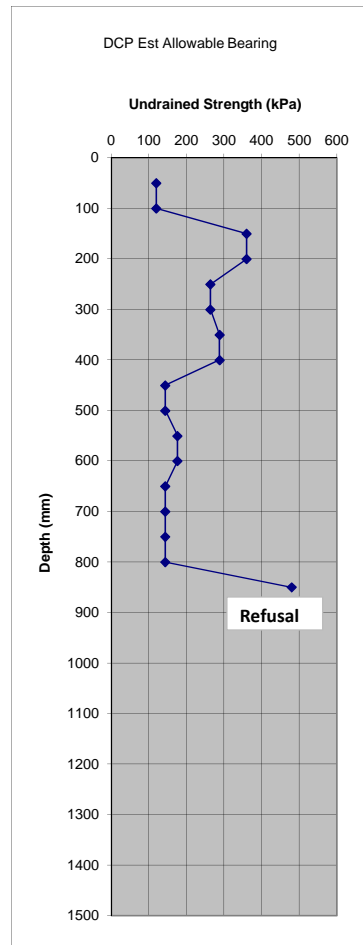
Note: The Allowable Bearing Capacity data applies to cohesive soils only and is based on bearing capacity factor $N_c = 5$ and $FOS = 4$. Approximate $C_u = 0.8 \times$ allowable bearing capacity.

Caution: The Allowable Bearing derived using this method should be used with care and consideration should be made of soil moisture condition at the time of the test in relation to that expected during service life of the foundation.

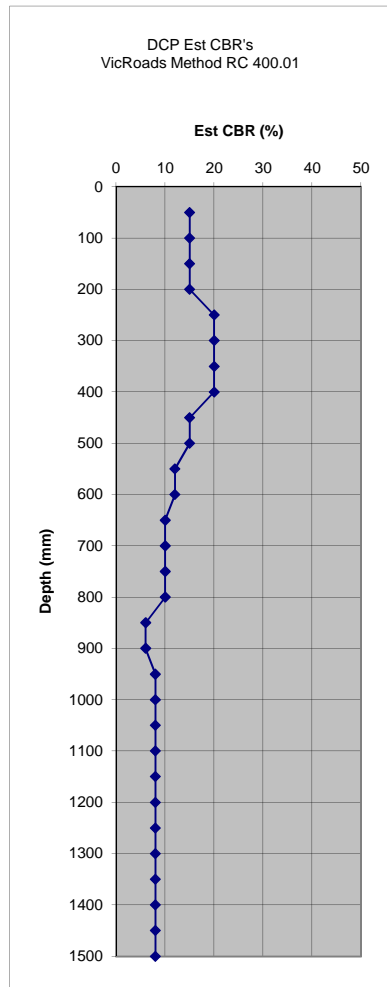
This method covers the calculation of the estimated California Bearing Ratio (CBR) of cohesive soils from the penetration results obtained using the dynamic cone penetrometer described in AS 1289.6.3.2

Caution: The CBR data derived using this method should be used with care and due consideration should be made of soil moisture condition at the time of the test in relation to that expected during service life of the pavement.

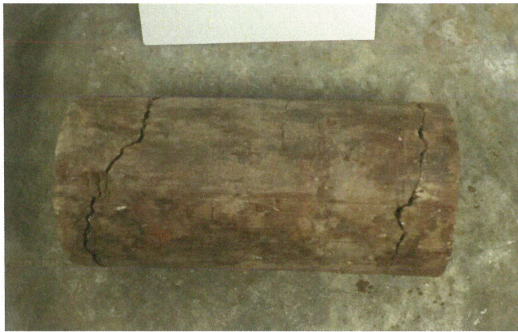
| Shrink-Swell Index (Iss) % | Shrinkage (Esh) % | Swell (Esw) % | Shrink Moisture Content % | Swell Moisture Content % | Estimated % of Significant inert inclusions % |
| 5.3 | 7.2 | 4.8 | 28.5 | 28.5 | 0% |

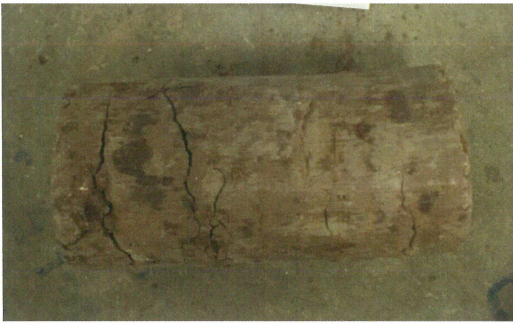
| Shrink-Swell Index (Iss) % | Shrinkage (Esh) % | Swell (Esw) % | Shrink Moisture Content % | Swell Moisture Content % | Estimated % of Significant inert inclusions % |
| 5.0 | 6.2 | 5.8 | 26.1 | 26.1 | 0% |

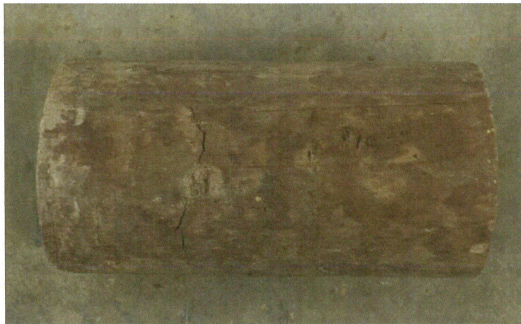
| Shrink-Swell Index (Iss) % | Shrinkage (Esh) % | Swell (Esw) % | Shrink Moisture Content % | Swell Moisture Content % | Estimated % of Significant inert inclusions % |
| 6.5 | 10.8 | 1.8 | 33.0 | 33.0 | 0% |
